# 99-7898 INSTALLATION INSTRUCTIONS

**APPLICATIONS**

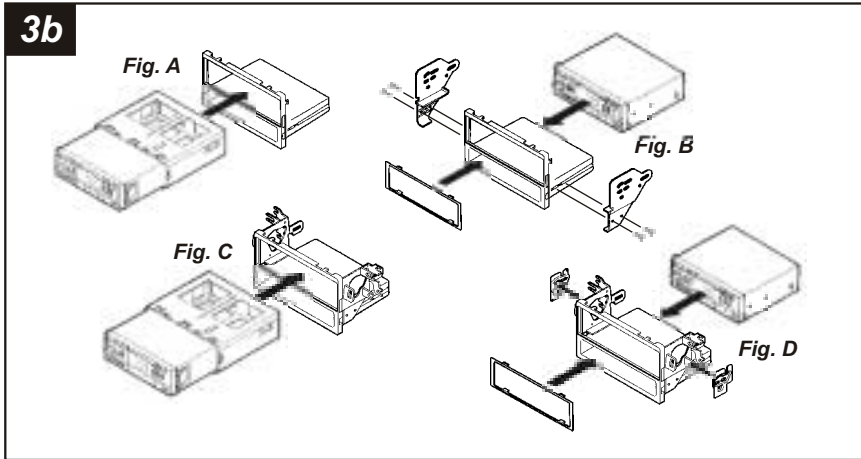
3b

**ACCORD 1990-97, CIVIC 1999-00, CL 1997-99, CRV 1997-02, INTEGRA 1990-01, LEGEND 1990-96, OASIS 1995-98, ODYSSEY 1995-98, PRELUDE 1989-01, RSX 2002, TL 1996-98, VIGOR 1992-94: DIN HEAD UNITS:** Slide the DIN cage into the kit and secure by bending the metal locking tabs down. Slide the aftermarket head unit into the cage until secure (see Fig. A). **ISO HEAD UNITS:** Snap the **ISO Trimming** into the **Radio Housing**. Mount the **ISO Brackets** to the Radio Housing with (4) #8 x 3/8" Phillips Screws supplied. Slide the aftermarket head unit into the Housing, align the holes in the unit with the holes in the Brackets and mount with the screws supplied with the unit (see Fig. B).

**ACCORD 1998-02, ODYSSEY 1999-02: DIN HEAD UNITS:** Slide the DIN cage into the kit and secure by bending the metal locking tabs down. Slide the aftermarket head unit into the cage until secure (see Fig. C). **ISO HEAD UNITS:** Attach the **ISO Spacers** onto the sides of the **Mounting Brackets** and snap the **ISO Trimming** into the **Radio Housing**. Slide the aftermarket head unit into the Housing, align the holes in the unit with the holes in the ISO Spacers and mount with the screws supplied with the unit (see Fig. D).

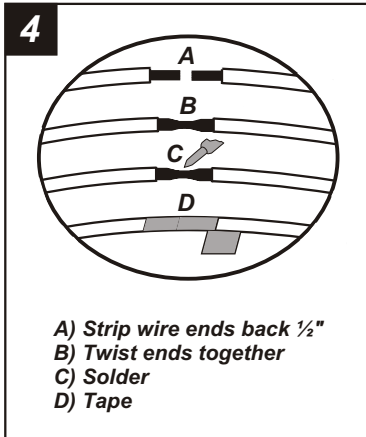
Locate the factory wiring harness in the dash. Metra recommends using the proper mating adaptor and making connections as shown. (Isolate and individually tape off the ends of any unused wires to prevent electrical short circuit).

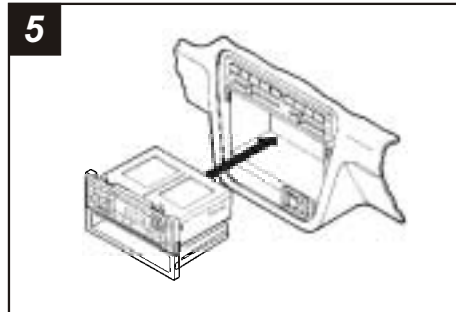
Re-connect the battery terminal and test the unit for proper operation. Slide the head unit/kit assembly into the sub-dash or trim bezel (depending on the vehicle) and secure by reversing the steps in the dash disassembly. **ACCORD 1994-97 and CL 1997-99:** Mount the Rear Support Bracket to the rear support provision with (2) bolts previously removed in the dash disassembly. **RSX 2002:** Mount the Rear Support Bracket to the rear support provision with (2) #8 x 3/4" Phillips Pan-head Screws included.

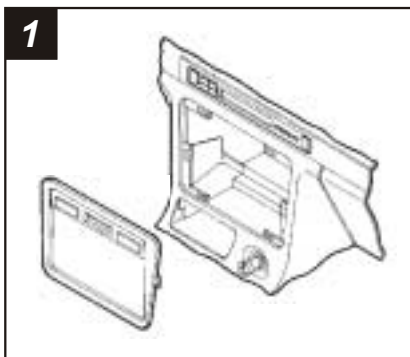
## ACURA CL 1997-99

Disconnect the negative battery terminal to prevent an accidental short circuit. Unclip the radio trim bezel and disconnect the clock and climate control wiring. Remove (2) 8mm hex-head screws securing the factory head unit and disconnect the wiring.

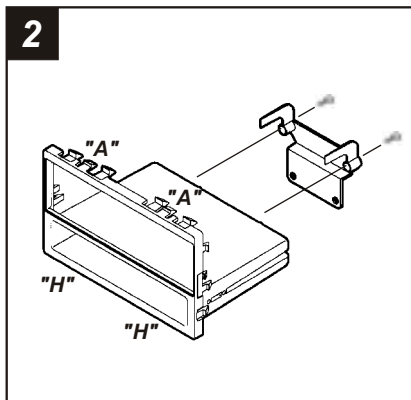
Cut and remove the all mounting clips on the **Radio Housing** EXCEPT clips "A" and "H". (The clips can be identified by the stamped letter near each clip). Mount the **Rear Support Bracket #R1** to the back of the Radio Housing with (2) #8 x 3/8" Phillips Pan-head Screws supplied. Skip to step #3b on Page 11.

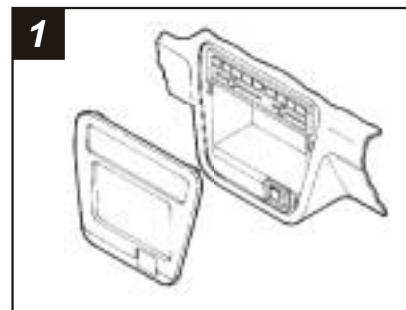
## HONDA Prelude 1997-01

Disconnect the negative battery terminal to prevent an accidental short circuit. Using a panel removal tool, unclip the radio trim bezel and remove (some force may be required). Remove (4) Phillips screws securing the factory head unit/bracket housing assembly and disconnect the wiring. Remove (4) Phillips screws securing the factory head unit to the bracket housing and remove.

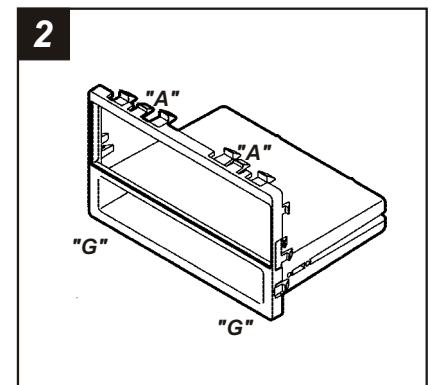
Cut and remove the all mounting clips on the **Radio Housing** EXCEPT clips "A" and "G". (The clips can be identified by the stamped letter near each clip). Skip to step #3b on Page 11.

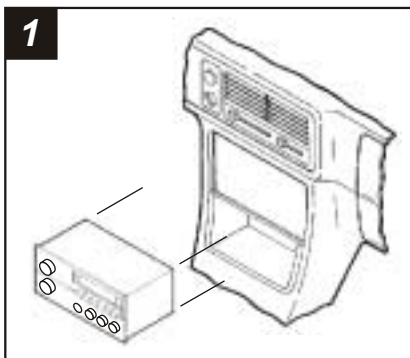
## ACURA Integra 1990-93

Disconnect the negative battery terminal to prevent an accidental short circuit. Remove (3) screws from each side of the center console and remove the console. Remove (2) screws securing the factory head unit to the sub-dash support bracket. Slide the head unit/pocket assembly out and disconnect the wiring.

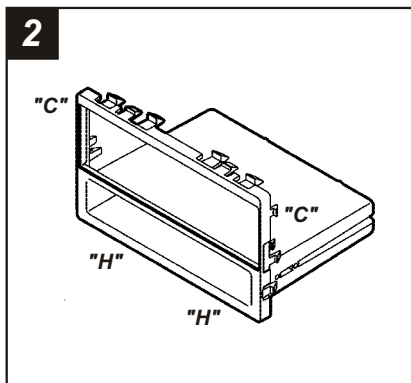
Cut and remove the all mounting clips on the **Radio Housing** EXCEPT clips "C" and "H". (The clips can be identified by the stamped letter near each clip). Skip to step #3b on Page 11.

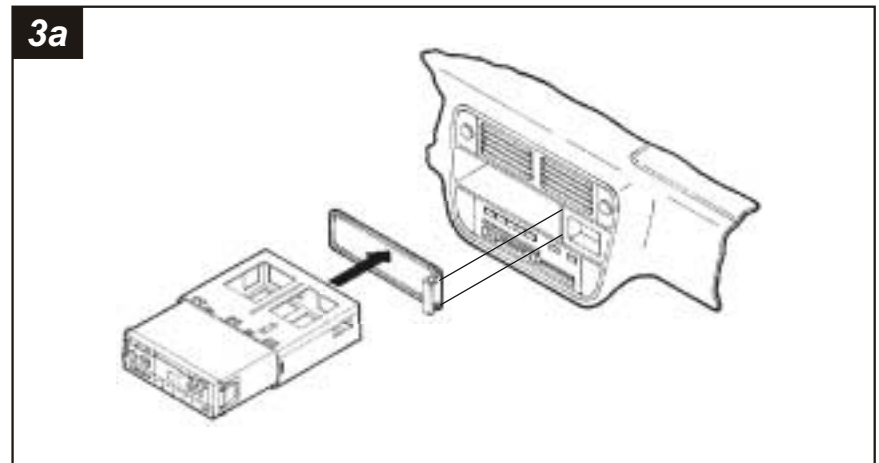
### **CIVIC 1996-98:**

**DIN HEAD UNITS:** Disconnect the negative battery terminal to prevent an accidental short circuit. Position the **Faceplate** in the radio opening by inserting the locating pins on the Housing into the holes in the sub-dash. (NOTE: If a radio dummy plate was removed during the dash disassembly, cut and remove the locating pins on the Radio Housing). Slide the DIN cage into the kit and secure by bending the metal locking tabs down. Slide the aftermarket head unit into the cage until secure. (THIS CONCLUDES THE INSTALLATION).

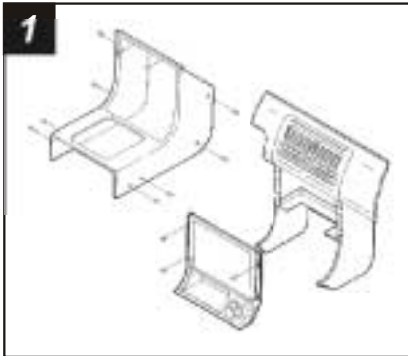
1

Disconnect the negative battery terminal to prevent an accidental short circuit. Remove (2) screws from the top of the console trim bezel. Slide the front seats back and remove (4) Phillips screws from each side of the bezel. Pull up on the console trim bezel and remove. Using an angled screwdriver, remove (2) screws securing the gear shifter bracket to the bezel. Remove (4) screws from the radio trim bezel, remove the factory head unit assembly and disconnect the wiring.

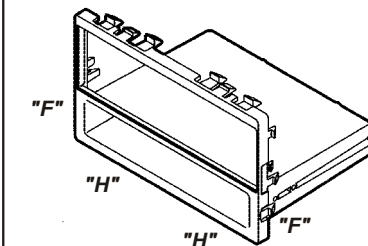
2

Cut and remove the all mounting clips on the **Radio Housing** EXCEPT clips "F" and "H". (The clips can be identified by the stamped letter near each clip). Skip to step #3b on Page 11.

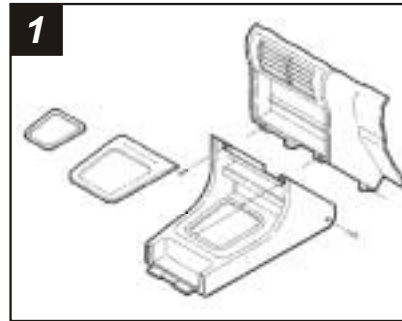
1

Disconnect the negative battery terminal to prevent an accidental short circuit. Remove the cover cap located under the emergency brake and remove (2) screws exposed. Remove (2) screws from the rear corners of the lower dash trim bezel and remove. Remove the ashtray and (2) screws exposed. Unsnap the ashtray housing and disconnect the cigarette lighter harness. Remove the gear shifter knob and unsnap the shifter trim. Remove (2) screws below the radio opening and remove the upper dash trim bezel. Remove (2) 8mm screws securing the factory head unit and disconnect the wiring.

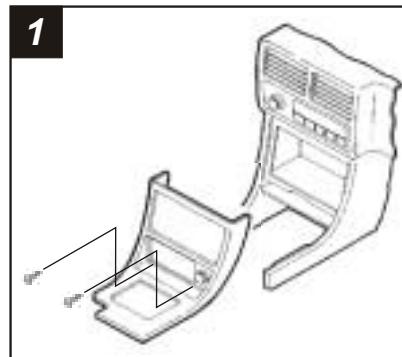
1

Disconnect the negative battery terminal to prevent an accidental short circuit. Remove (2) screws below the ashtray. Unclip the dash trim bezel. Disconnect the cigarette lighter wiring and remove the bezel. Remove (2) bolts securing the rear of the factory head unit and disconnect the wiring.

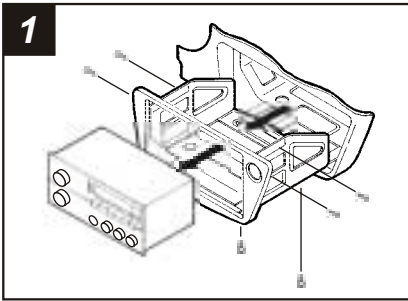
## ACURA RSX 2002

Disconnect the negative battery terminal to prevent an accidental short circuit. Unclip the lower dash panel (containing the power outlet) and remove the panel. Reach into the opening and remove (2) Phillips screws from the base of the factory head unit. Slide the factory head unit (w/ bracket assembly) from the dash and disconnect the wiring. Remove (4) Phillips screws securing the factory head unit to the bracket assembly and remove the unit. (If a factory pocket is present, remove (4) Phillips screws securing the pocket to the bracket assembly and remove).

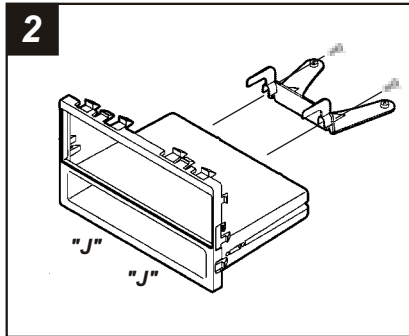
Cut and remove the all mounting clips on the **Radio Housing** EXCEPT clips "J". (The clips can be identified by the stamped letter near each clip). Mount the **Rear Support Bracket #R2** to the back of the Radio Housing with (2) #8 x 3/8" Phillips Pan-head Screws supplied. Skip to step #3b on Page 11.

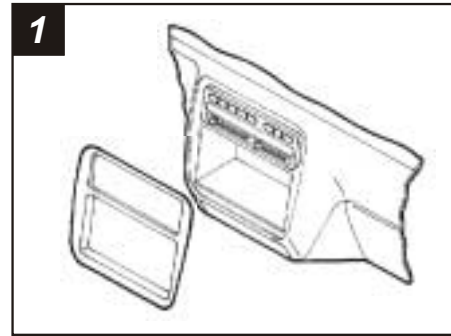
## HONDA Odyssey 1995-98 / ISUZU Oasis 1996-99

Disconnect the negative battery terminal to prevent an accidental short circuit. Lower the glove box assembly. Remove (2) Phillips screws exposed on the right side of the underdash. Remove (2) Phillips screws from the driver's side knee bolster and (1) Phillips screw in the coin pocket. Remove (5) Phillips screws from the underdash panel and remove the panel. Remove (4) Phillips screws from the cupholder assembly and remove. Remove (2) Phillips screws securing the factory head unit and disconnect the wiring.

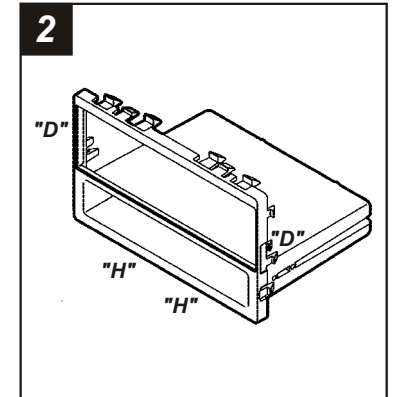
Cut and remove the all mounting clips on the **Radio Housing** EXCEPT clips "D" and "H". (The clips can be identified by the stamped letter near each clip). Skip to step #3b on Page 11.

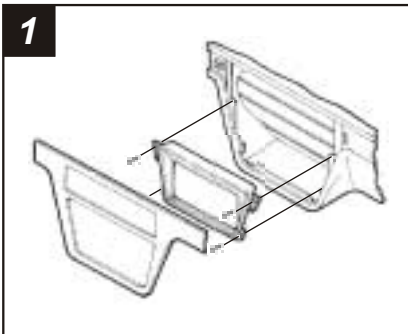
## ACURA TL 1996-98

Disconnect the negative battery terminal to prevent an accidental short circuit. Using a small screwdriver, unclip the perimeter of the radio trim bezel. Disconnect the climate control and rear defroster wiring and remove the bezel. Remove (4) Phillips screws securing the factory head unit/trim bezel assembly. Loosen (2) Phillips screws securing the back of the head unit to the metal housing and slide the unit out. (It is NOT necessary to remove the screws securing the metal housing to the bezel). Disconnect the wiring.

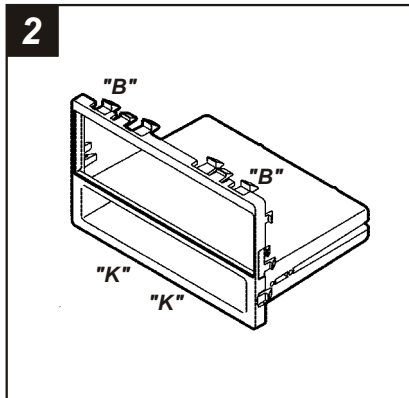
Cut and remove the all mounting clips on the **Radio Housing** EXCEPT clips "B" and "K". (The clips can be identified by the stamped letter near each clip). Skip to step #3b on Page 11.

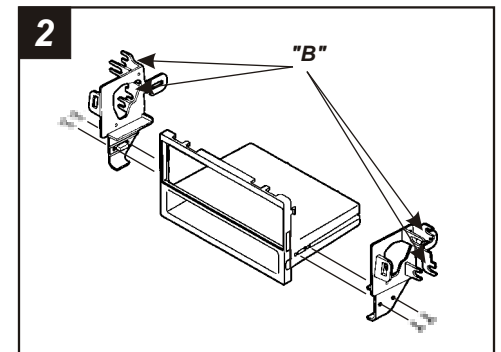
Cut and remove the mounting clips from the **Radio Housing**. Locate tabs "B" on the **Mounting Brackets** for mounting, cut and remove tabs "A". (The tabs can be identified by the stamped letter near each tab). Secure the Brackets to the Housing with (4) #8 x 3/8" Phillips Pan-head Screws. Skip to step #3b on Page 11.

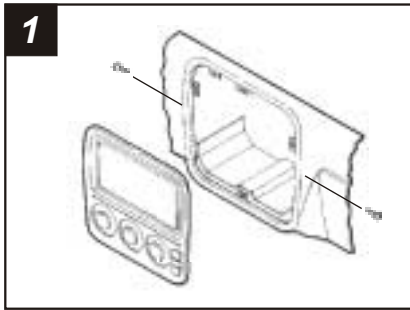
## HONDA CR-V 1997-01

Disconnect the negative battery terminal to prevent an accidental short circuit. Open the glove box, squeeze the retaining clips and remove the stoppers. Lower the glove box and remove (2) Phillips screws from the left edge. Remove (2) Phillips screws from the lower steering column panel and remove. Unclip the lower console cover (below the ashtray and pocket) and remove. Remove (2) Phillips screws from the base of the center console, open the console pocket and remove the (4) outer screws exposed. Unclip the center console and remove. Remove (2) Phillips screws securing the radio trim bezel, disconnect the wiring, and remove the trim bezel/head unit assembly. Remove (4) Phillips screws securing the head unit to the bezel and remove.

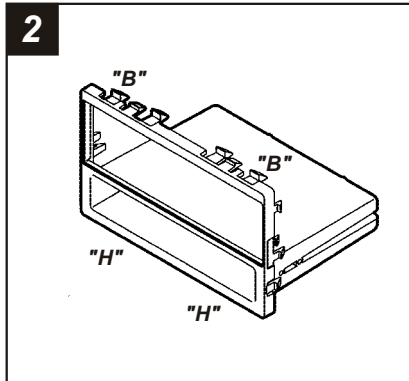
Cut and remove the all mounting clips on the **Radio Housing** EXCEPT clips "**B**" and "**H**". (The clips can be identified by the stamped letter near each clip). *Skip to step #3b on Page 11.*

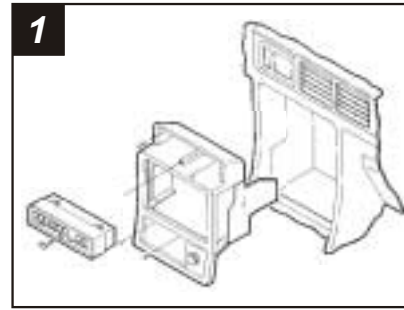
## ACURA Vigor 1991-96

Disconnect the negative battery terminal to prevent an accidental short circuit. Remove the access cap from the climate control cluster and (1) screw exposed. Unclip the cluster and remove (2) screws exposed. Remove the ashtray and (2) Phillips screws exposed. Remove the cover caps from each front corner of the center console and the screws exposed. Open the storage compartment, lift up the carpet and remove (2) screws exposed. Lift up on the center console and remove. Unclip the radio trim bezel and disconnect the wiring. Remove (2) bolts from the back of the factory head unit and disconnect the wiring.

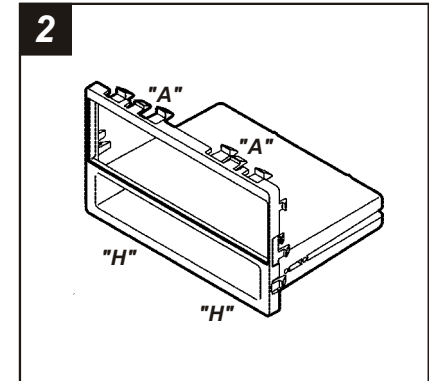
Cut and remove the all mounting clips on the **Radio Housing** EXCEPT clips "**A**" and "**H**". (The clips can be identified by the stamped letter near each clip). *Skip to step #3b on Page 11.*

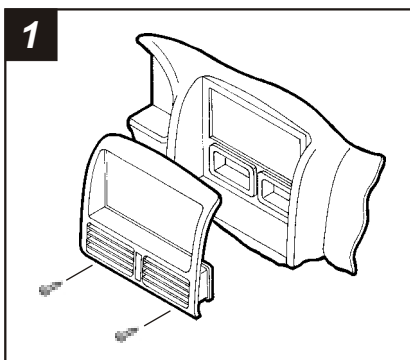
## HONDA CR-V 2002

Disconnect the negative battery terminal to prevent an accidental short circuit. Remove (2) Phillips screws from the bottom edge of the radio trim bezel. Unclip the trim bezel and remove. Remove (4) Phillips screws securing the factory head unit and disconnect the wiring.

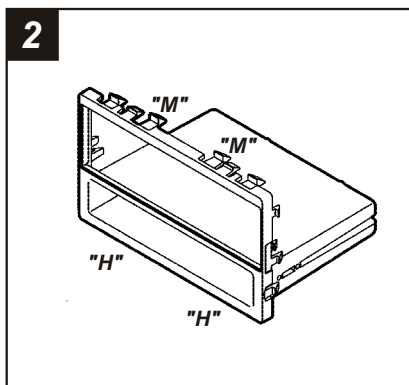
Cut and remove the all mounting clips on the **Radio Housing** EXCEPT clips "**M**" and "**H**". (The clips can be identified by the stamped letter near each clip). *Skip to step #3b on Page 11.*

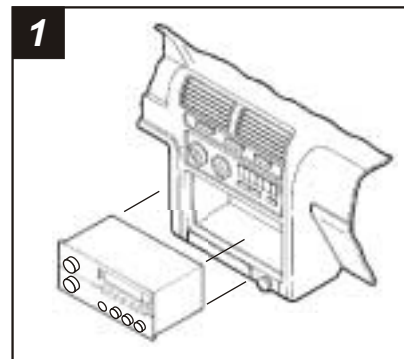
## HONDA Accord 1990-93

Disconnect the negative battery terminal to prevent an accidental short circuit. Remove (4) screws from the lower portion of the center console. Remove the gear shifter knob and lift the console out. Remove the ashtray and ashtray bracket. Remove (2) screws from the bottom of the head unit support, slide the unit out and disconnect the wiring.

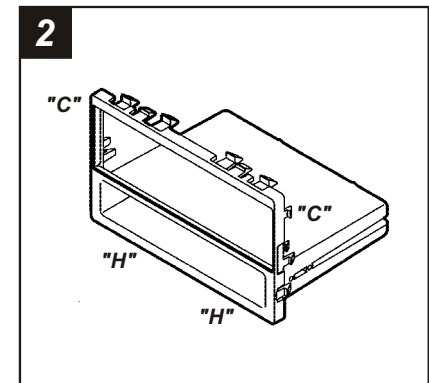
Cut and remove the all mounting clips on the **Radio Housing** EXCEPT clips "**C**" and "**H**". (The clips can be identified by the stamped letter near each clip). *Skip to step #3b on Page 11.*

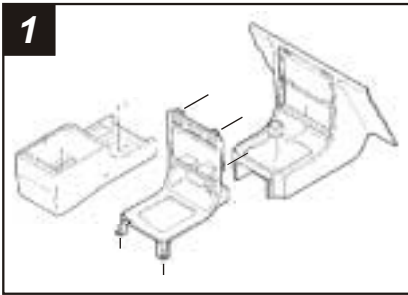
## HONDA Accord 1994-97

Disconnect the negative battery terminal to prevent an accidental short circuit. Remove the ashtray and (1) ¼" #8 Phillips screw exposed. Open the storage compartment and remove (2) #8 Phillips screws exposed. Remove the cupholder tray and (3) #8 Phillips screws inside. Lift the center console out and remove (2) Phillips screws exposed at the base of the dash trim bezel. Unclip the bezel and remove. Remove (2) hex-head screws securing the factory head unit and disconnect the wiring.

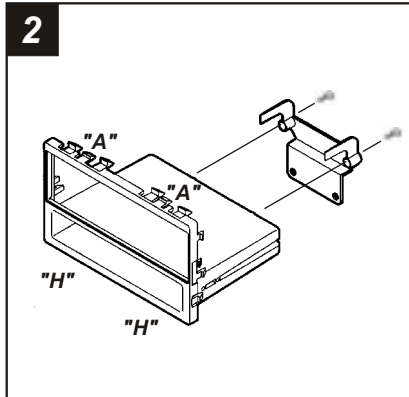
Cut and remove the all mounting clips on the **Radio Housing** EXCEPT clips "A" and "H". (The clips can be identified by the stamped letter near each clip). Mount the **Rear Support Bracket #R1** to the back of the Radio Housing with (2) #8 x 3/8" Phillips Pan-head Screws supplied. Skip to step #3b on Page 11.

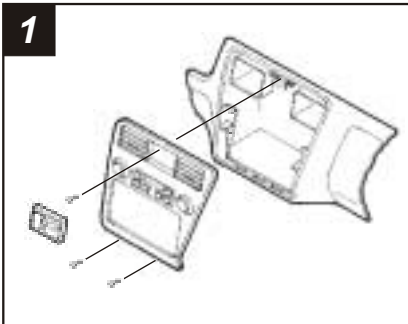
## HONDA Accord 1998-02

Disconnect the negative battery terminal to prevent an accidental short circuit. Unsnap the clock panel, disconnect the wiring and remove. Remove (1) Phillips screw exposed in the clock cavity. Remove (2) Phillips screws below the factory head unit. Unclip the radio trim bezel and disconnect the wiring. Remove (4) Phillips screws securing the factory head unit assembly and disconnect the wiring. Remove (2) screws securing the factory pocket to the assembly.

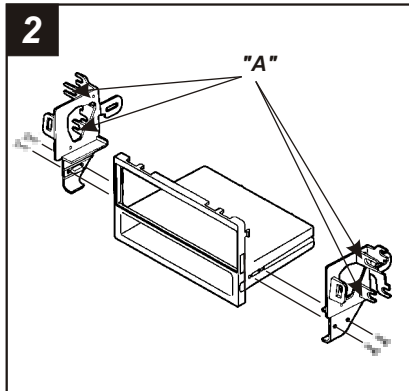
Cut and remove the mounting clips from the **Radio Housing**. Locate tabs "A" on the **Mounting Brackets** for mounting, cut and remove tabs "B". (The tabs can be identified by the stamped letter near each tab). Secure the Brackets to the Housing with (4) #8 x 3/8" Phillips Pan-head Screws. Skip to step #3b on Page 11.

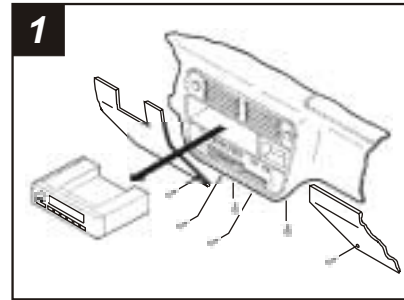
## HONDA Civic 1996-98

Disconnect the negative battery terminal to prevent an accidental short circuit. Remove (2) Phillips screws from the bottom edge of the glove box door and remove the door. Remove (3) Phillips screws from the lower steering column panel. Pull straight down on the lower steering column panel and remove the panel. Remove (2) Phillips screws under the climate control panel. Remove (4) Phillips screws from the lower dash location. Remove (2) 8mm hex-head screws securing the bottom-rear of the factory head unit and disconnect the wiring.

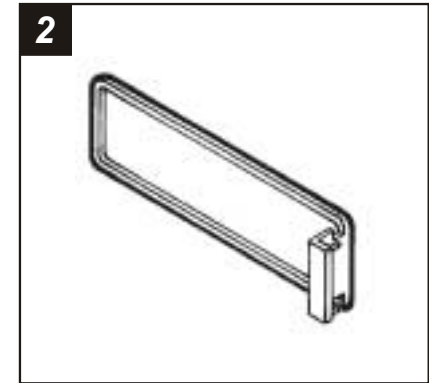
Locate the **Faceplate**. Skip to step #3a on Page 10.

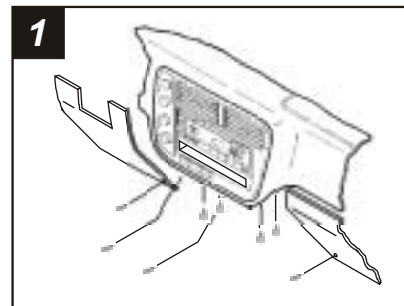
## HONDA Civic 1999-00

Disconnect the negative battery terminal to prevent an accidental short circuit. Remove (2) Phillips screws from the bottom edge of the glove box door and remove the door. Remove (3) Phillips screws from the lower steering column panel. Pull straight down on the lower steering column panel and remove the panel. Remove (2) Phillips screws under the climate controls. Remove (4) Phillips screws from the lower dash location. Remove (4) Phillips screws securing the bottom of the dash trim bezel/head unit assembly and pull the assembly out as far as possible. Cut the zip ties securing the head unit and climate control wires, slide the dash trim bezel/head unit assembly from the dash cavity and disconnect the wiring.

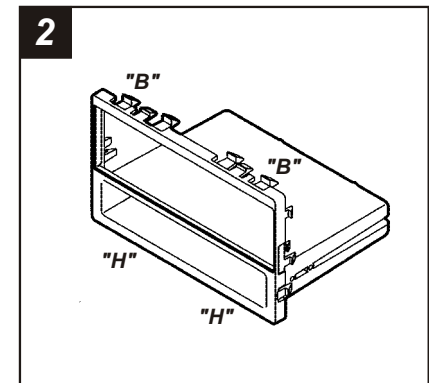
Cut and remove the all mounting clips on the **Radio Housing** EXCEPT clips "B" and "H". (The clips can be identified by the stamped letter near each clip). Skip to step #3b on Page 11.
