OEM-1

Interfacing Information Bulletin Number 5

June 5, 1998

Vehicles: 1998 Jeep Grand Cherokee and other late model Chrysler vehicles.

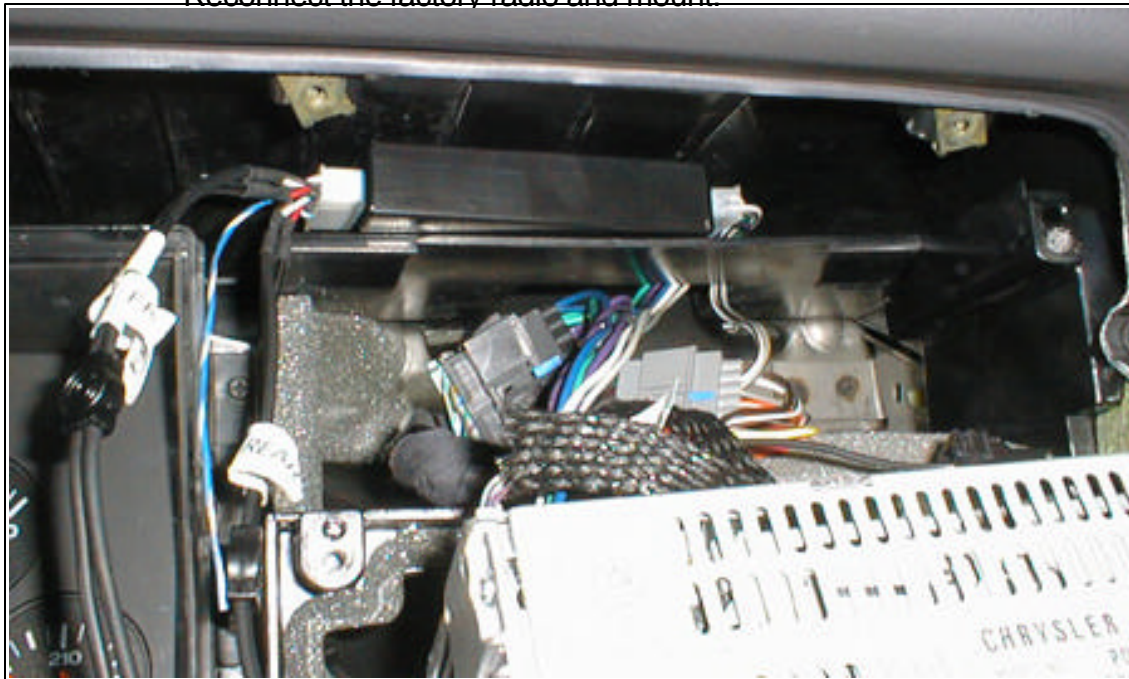
Symptom: Due to limited space around and behind radio installation may be difficult

Correction: Plug the ADD-CHR cable into the vehicle harness first and route the plug that connects to the interface box up through the radio cavity. The OEM-1 and the AMP-RCA already plugged in, can then be plugged in and remain above the radio between the radio cavity and dash pad. Route the RCA cables and the amplifier trigger down between the radio and instrument cluster and out the bottom of the dash.

Reconnect the factory radio and mount.
