KIT FEATURES

99-7417

INSTALLATION INSTRUCTIONS

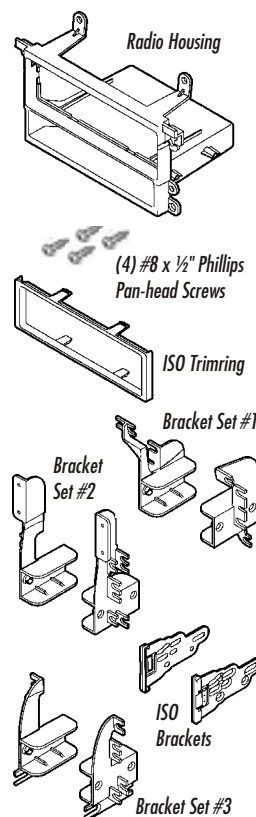
KIT COMPONENTS

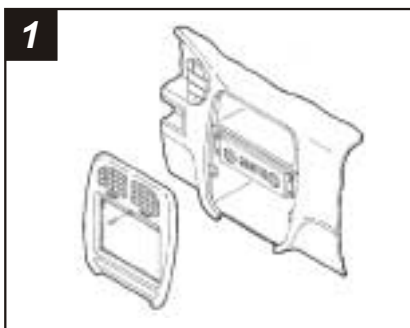
MERCURY Villager 1993-95

Disconnect the negative battery terminal to prevent an accidental short circuit. Remove (1) screw above the climate controls. Unclip the radio trim bezel and remove. Remove (4) Phillips screws securing the factory radio housing and remove the housing. Disconnect the wiring. Remove (8) Phillips screws securing the factory radio to the factory radio housing and remove the radio.

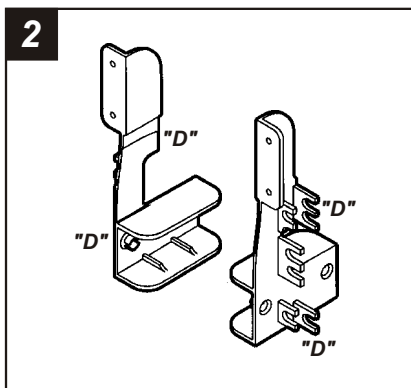
Cut and remove all mounting tabs on **Bracket Set #2** EXCEPT tabs "D". (The tabs can be identified by the stamped letter by each tab). Skip to the *Installation Instructions for ALL VEHICLES on Page #9*.

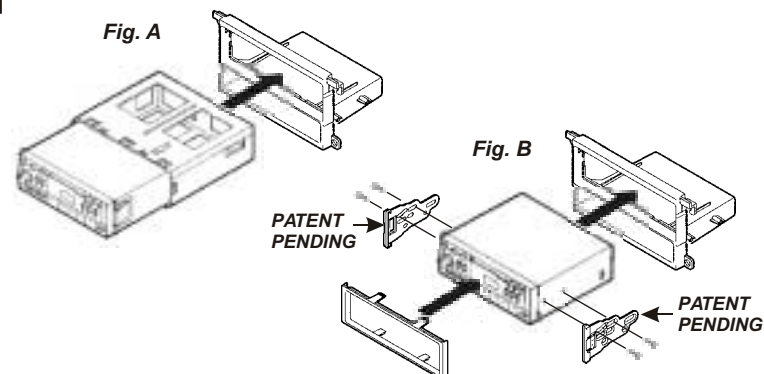
DIN HEAD UNITS: Slide the DIN cage into the kit and secure by bending the metal locking tabs down. Slide the aftermarket head unit into the cage until secure (see Fig. A).

ISO HEAD UNITS: Secure the **ISO Brackets** to the sides of the aftermarket head unit with the screws supplied with the unit. Slide the head unit assembly into the **Radio Housing** until the side clips engage and attach the **ISO Trimming** over the mounted head unit (see Fig. B).

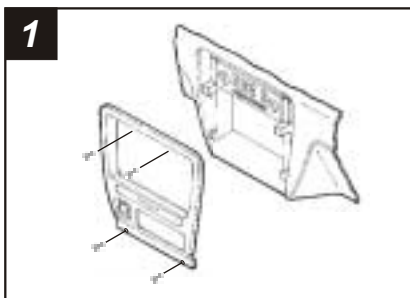
MERCURY Villager 1996-98

Disconnect the negative battery terminal to prevent an accidental short circuit. Remove (4) plastic screws from the base of the storage compartment. Pop out (4) anchor clips (securing the screws) and remove the compartment. Remove (2) Phillips screws from the base of the radio trim bezel. Remove (2) Phillips screws above the radio opening. Remove the ashtray. Pull up and out on the radio trim bezel and remove the bezel. Remove (4) Phillips screws securing the factory radio housing and remove the housing. Disconnect the wiring. Remove (2) Phillips screws securing the factory radio to the housing and remove the radio.

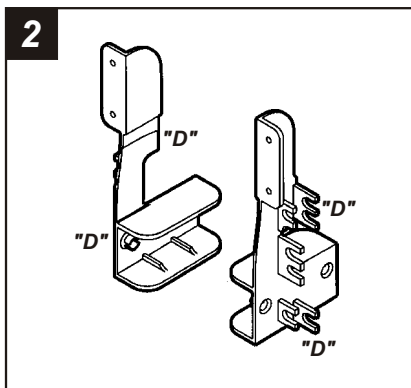
Cut and remove all mounting tabs on **Bracket Set #2** EXCEPT tabs "D". (The tabs can be identified by the stamped letter by each tab). Skip to the *Installation Instructions for ALL VEHICLES on Page #9*.

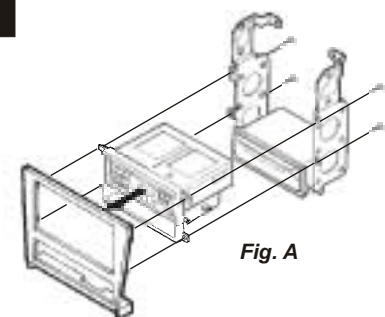
MAXIMA 1995-99, I-30: Mount the head unit/kit assembly to the trim bezel and factory bracket assembly with factory screws and mount to the sub-dash with factory screws (Fig. A).

MAXIMA 2000-02: Mount the head unit/kit assembly to the factory bracket assembly with (4) **Phillips Flat-head Screws** supplied and mount to the sub-dash with factory screws.

240SX: Mount the head unit/kit assembly to the trim bezel (using tabs "B") with factory screws and then to the sub-dash (using tabs "C") with factory screws.

200SX, ALTIMA, FRONTIER, PATHFINDER, QUEST, SENTRA, VILLAGER, XTERRA: Mount the head unit/kit assembly to the sub-dash with factory screws.

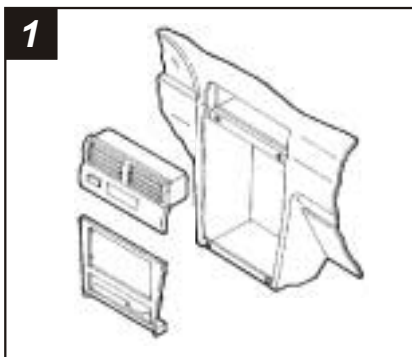
INFINITI I-30 1996-99

1 Disconnect the negative battery terminal to prevent an accidental short circuit. Unclip the gear shifter trim bezel and remove (2) screws exposed. Remove (1) screw to the left of the ashtray and unclip the ashtray assembly. Unclip the clock/vent assembly and remove. Remove (4) screws from the top of the mounting bracket assembly. Disconnect the wiring and remove the assembly. Remove the screws securing the mounting brackets to the assembly and remove the brackets.

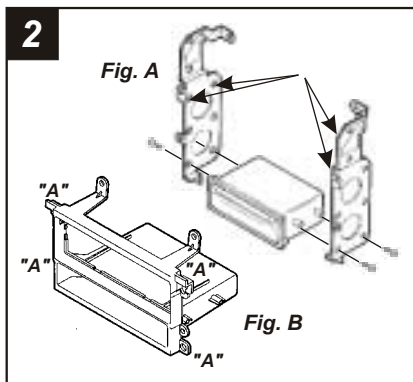
2 Using a hammer, flatten the protruding screw holes on the factory mounting brackets. Mount the factory pocket to the brackets with those screws previously removed in step #1 (Fig. A). Cut and remove all mounting tabs on the **Radio Housing** EXCEPT tabs "A" (Fig. B). The tabs can be identified by the stamped letter on each tab. Skip to the *Installation Instructions for ALL VEHICLES* on Page #9.

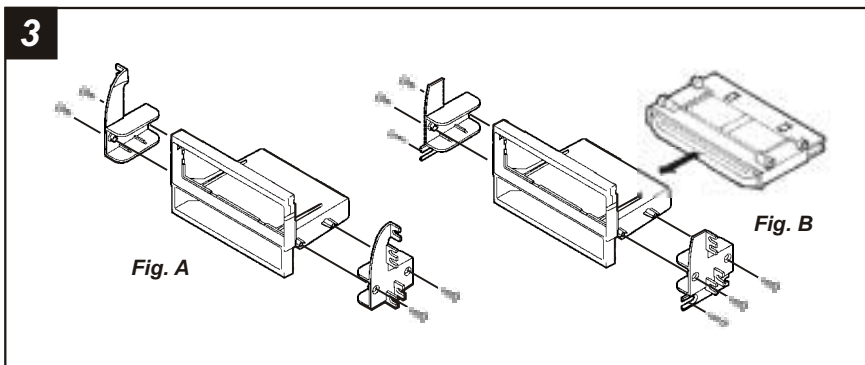
ALL VEHICLES

ALTIMA, FRONTIER, PATHFINDER, QUEST, VILLAGER, XTERRA: Cut and remove the mounting tabs from the **Radio Housing** and mount the converted Brackets to the Housing with (4) #8 x 1/2" Phillips Flat-head Screws supplied (Fig. A).

200SX, SENTRA: Cut and remove the mounting tabs from the **Radio Housing**. Mount one of the converted Brackets to the Housing with (2) #8 x 1/2" Phillips Flat-head Screws supplied and mount one side of the cupholder to the Bracket with (1) factory screw and (1) locating pin. Mount the other Bracket to the Housing with (2) #8 x 1/2" Phillips Flat-head Screws supplied and mount the other side of the cupholder with (1) factory screw and (1) locating pin (Fig. B).

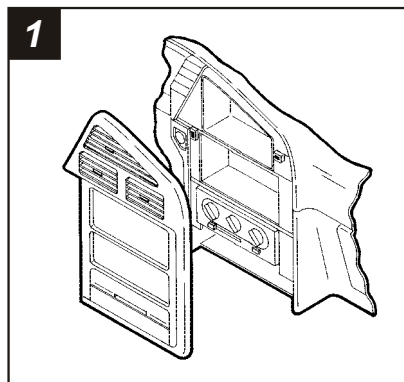
MERCURY Villager / NISSAN Quest 1999-02

1 Disconnect the negative battery terminal to prevent an accidental short circuit. Open the ashtray/cupholder assembly, depress the retaining clips on each side and remove the assembly. Remove (2) Phillips screws from each side of the ashtray/cupholder assembly. Remove (4) plastic rivets from the lower pocket and slide the pocket back. (NOTE: It is NOT necessary to remove the pocket. Unclip the dash trim bezel and remove. Remove (4) Phillips screws securing the factory head unit and disconnect the wiring.

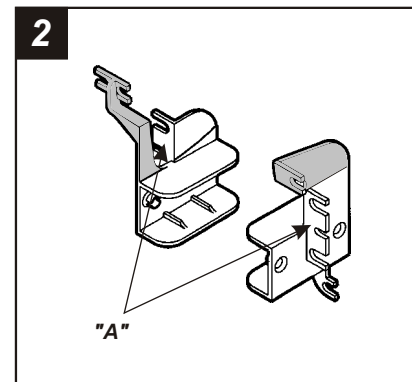
2 Cut **Bracket Set #1** along the scored lines removing the SHADED portions of the Brackets. Cut and remove all mounting tabs EXCEPT tabs "A". (The tabs can be identified by the stamped letter by each tab). Skip to the *Installation Instructions for ALL VEHICLES* on Page #9.

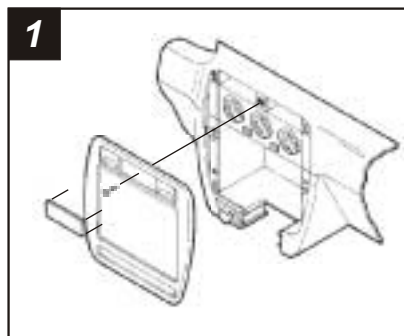
NISSAN 200SX 1995-98

1 Disconnect the negative battery terminal to prevent an accidental short circuit. Unclip the dummy plate from the center of the switch panel (above the radio opening). Unclip the radio trim bezel and remove. Remove (4) Phillips screws securing the factory head unit and disconnect the wiring. Remove (2) Phillips screws securing the factory cupholder and remove.

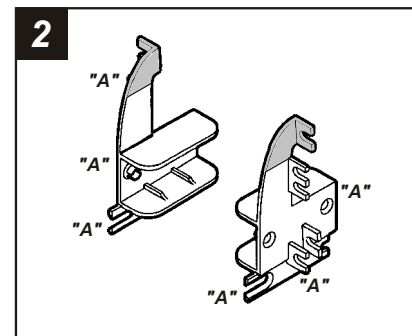
2 Cut **Bracket Set #3** along the scored lines removing the SHADED portions of the Brackets. Cut and remove all mounting tabs EXCEPT tabs "A". (The tabs can be identified by the stamped letter by each tab). Skip to the *Installation Instructions for ALL VEHICLES* on Page #9.

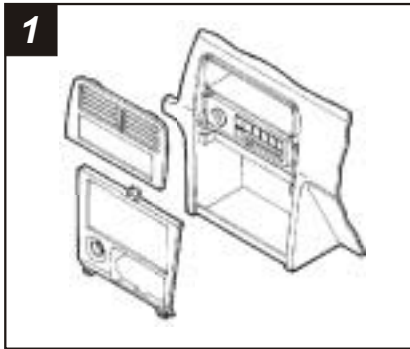
NISSAN 240SX 1995-98

1
Disconnect the negative battery terminal to prevent an accidental short circuit. Unclip the climate control trim bezel and remove (2) screws exposed. Unclip the gear shifter trim bezel and remove (2) screws exposed. Remove the ashtray and (1) screw exposed. Unclip the radio trim bezel (the factory head unit, pocket and mounting brackets are secured to the bezel). Disconnect the wiring. Remove the screws securing the mounting brackets to the assembly and remove the brackets.

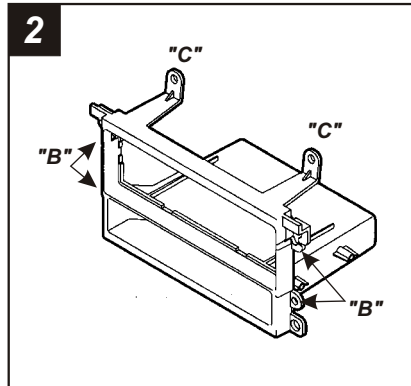
2
Cut and remove all mounting tabs on the **Radio Housing** EXCEPT tabs "**B**" and "**C**". (The tabs can be identified by the stamped letter on each tab). *Skip to the Installation Instructions for ALL VEHICLES on Page #9.*

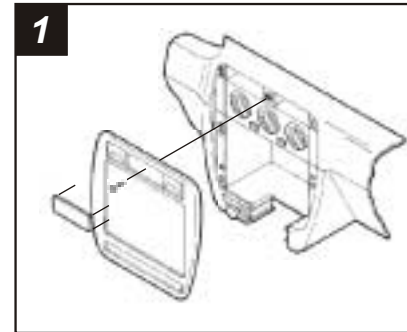
NISSAN Sentra 1995-99

1
Disconnect the negative battery terminal to prevent an accidental short circuit. Unclip the dummy plate from the center of the switch panel (above the radio opening). Unclip the radio trim bezel and remove. Remove (4) Phillips screws securing the factory head unit and disconnect the wiring. Remove (2) Phillips screws securing the factory cupholder and remove.

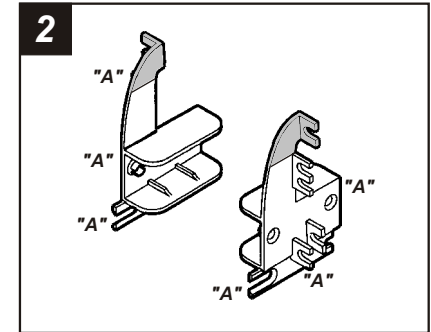
2
Cut **Bracket Set #3** along the scored lines removing the SHADED portions of the Brackets. Cut and remove all mounting tabs EXCEPT tabs "**A**". (The tabs can be identified by the stamped letter by each tab). *Skip to the Installation Instructions for ALL VEHICLES on Page #9.*

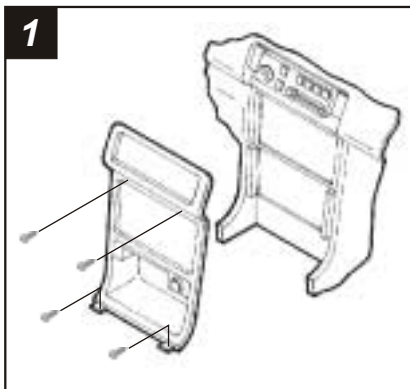
NISSAN Altima 1998-01

1
Disconnect the negative battery terminal to prevent an accidental short circuit. Unclip the gear shifter trim bezel and remove (2) Phillips screws exposed. Remove (2) Phillips screws above the radio opening. Unclip the radio trim bezel. Remove (4) Phillips screws from the factory head unit and disconnect the wiring.

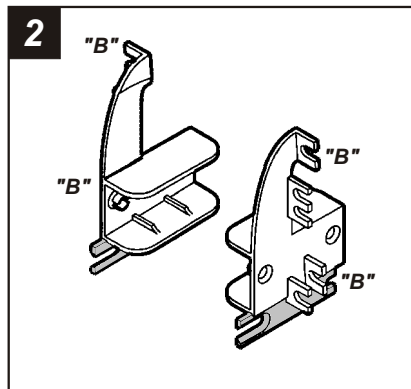
2
Cut **Bracket Set #3** along the scored lines removing the SHADED portions of the Brackets. Cut and remove all mounting tabs EXCEPT tabs "**B**". (The tabs can be identified by the stamped letter by each tab). *Skip to the Installation Instructions for ALL VEHICLES on Page #9.*

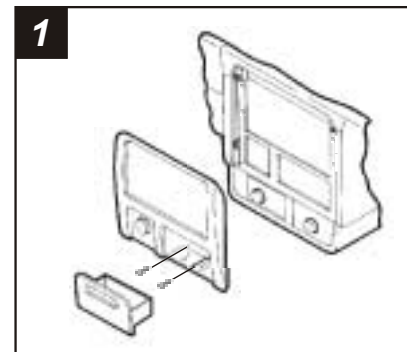
NISSAN Xterra 2000-01

1
Disconnect the negative battery terminal to prevent an accidental short circuit. Remove the ashtray and (2) Phillips screws exposed in the ashtray cavity. Unclip the radio trim bezel and remove. Remove (4) Phillips screws securing the factory head unit and disconnect the wiring.

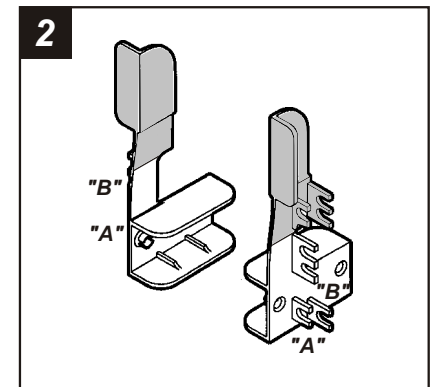
2
Cut **Bracket Set #2** along the scored lines removing the SHADED portions of the Brackets. Cut and remove all mounting tabs EXCEPT tabs "**A**" and "**B**". (The tabs can be identified by the stamped letter by each tab). *Skip to the Installation Instructions for ALL VEHICLES on Page #9.*

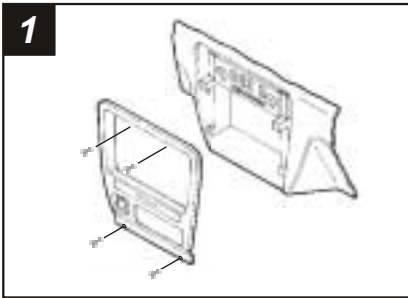
NISSAN Quest 1996-98

Disconnect the negative battery terminal to prevent an accidental short circuit. Remove (4) plastic screws from the base of the storage compartment. Pop out (4) anchor clips (securing the screws) and remove the compartment. Remove (2) Phillips screws from the base of the radio trim bezel. Remove (2) Phillips screws above the radio opening. Remove the ashtray. Pull up and out on the radio trim bezel and remove the bezel. Remove (4) Phillips screws securing the factory radio housing and remove the housing. Disconnect the wiring. Remove (2) Phillips screws securing the factory radio to the housing and remove the radio.

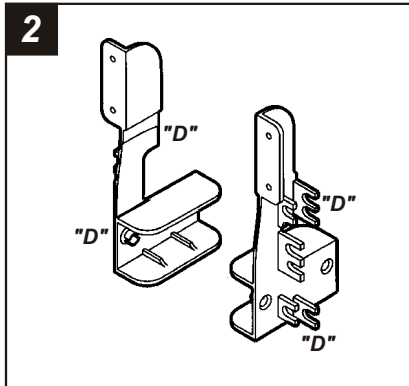
Cut and remove all mounting tabs on **Bracket Set #2** EXCEPT tabs "D". (The tabs can be identified by the stamped letter by each tab). Skip to the *Installation Instructions for ALL VEHICLES on Page #9*.

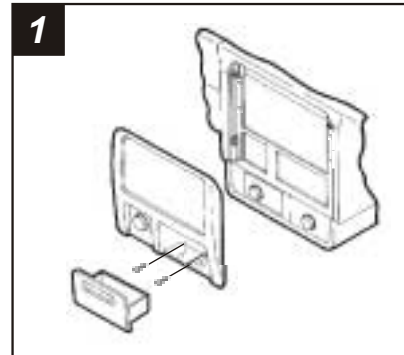
NISSAN Frontier 1998-01

Disconnect the negative battery terminal to prevent an accidental short circuit. Remove the ashtray and (2) Phillips screws exposed in the ashtray cavity. Unclip the radio trim bezel and remove. Remove (4) Phillips screws securing the factory head unit and disconnect the wiring.

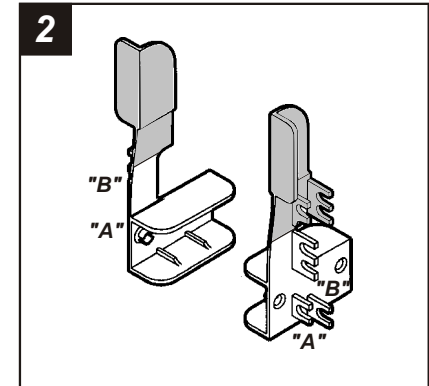
Cut **Bracket Set #2** along the scored lines removing the SHADED portions of the Brackets. Cut and remove all mounting tabs EXCEPT tabs "A" and "B". (The tabs can be identified by the stamped letter by each tab). Skip to the *Installation Instructions for ALL VEHICLES on Page #9*.

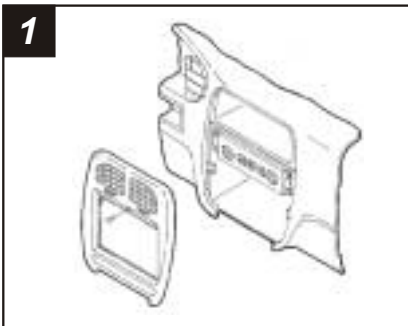
NISSAN Quest 1993-95

Disconnect the negative battery terminal to prevent an accidental short circuit. Remove (1) screw above the climate controls. Unclip the radio trim bezel and remove. Remove (4) Phillips screws securing the factory radio housing and remove the housing. Disconnect the wiring. Remove (8) Phillips screws securing the factory radio to the factory radio housing and remove the radio.

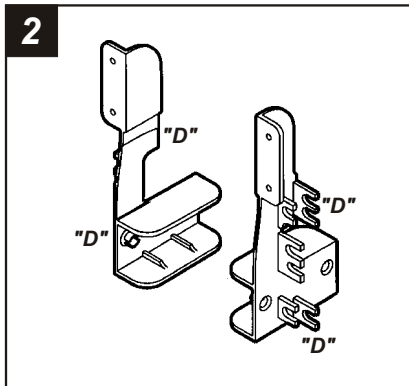
Cut and remove all mounting tabs on **Bracket Set #2** EXCEPT tabs "D". (The tabs can be identified by the stamped letter by each tab). Skip to the *Installation Instructions for ALL VEHICLES on Page #9*.

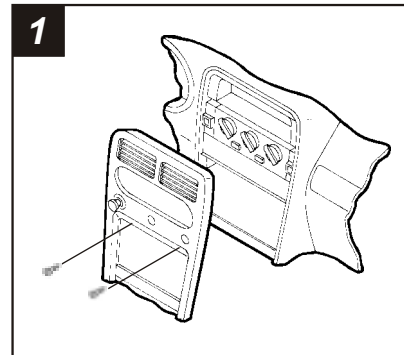
NISSAN Frontier / Xterra 2002

Disconnect the negative battery terminal to prevent an accidental short circuit. Unclip the gear shifter trim bezel and remove. Remove (2) Phillips screws exposed in the shifter cavity. Remove (2) Phillips screws under the climate control cluster. Unclip the radio trim bezel and remove. Remove (4) Phillips screws securing the factory head unit and disconnect the wiring. **CAUTION: DO NOT CYCLE THE KEY WHEN REMOVING A DASH WITH PASSENGER AIRBAG ON/OFF SWITCH).**

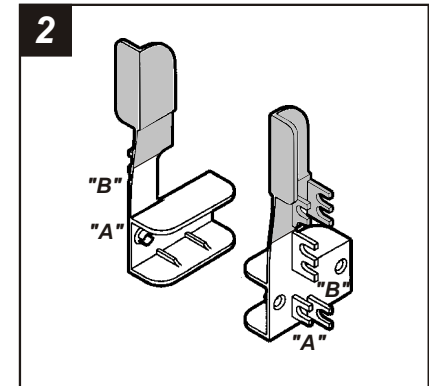
Cut **Bracket Set #2** along the scored lines removing the SHADED portions of the Brackets. Cut and remove all mounting tabs EXCEPT tabs "A" and "B". (The tabs can be identified by the stamped letter by each tab). Skip to the *Installation Instructions for ALL VEHICLES on Page #9*.

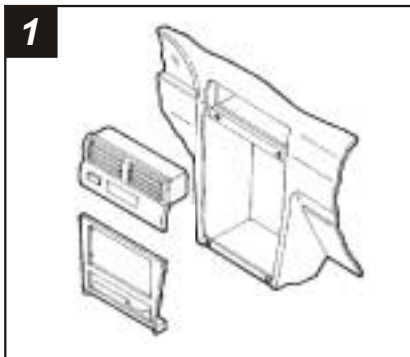
NISSAN Maxima 1995-99

Disconnect the negative battery terminal to prevent an accidental short circuit. Unclip the gear shifter trim bezel and remove (2) screws exposed. Remove (1) screw to the left of the ashtray and unclip the ashtray assembly. Unclip the clock/vent assembly and remove. Remove (4) screws from the top of the mounting bracket assembly. Disconnect the wiring and remove the assembly. Remove the screws securing the mounting brackets to the assembly and remove the brackets.

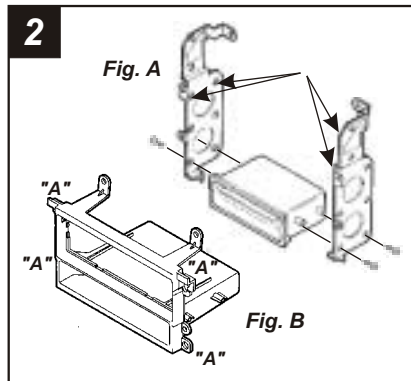
Using a hammer, flatten the protruding screw holes on the factory mounting brackets. Mount the factory pocket to the brackets with those screws previously removed in step #1 (Fig. A). Cut and remove all mounting tabs on the **Radio Housing** EXCEPT tabs "A" (Fig. B). The tabs can be identified by the stamped letter on each tab. Skip to the *Installation Instructions for ALL VEHICLES on Page #9*.

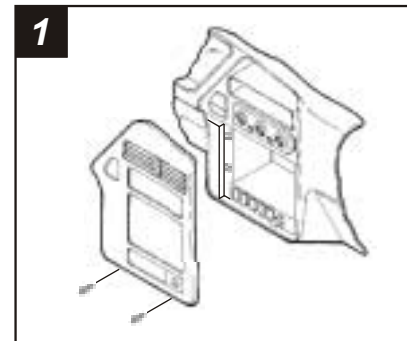
NISSAN Pathfinder 1996-00

Disconnect the negative battery terminal to prevent an accidental short circuit. Remove (2) screws from the base of the radio trim bezel. Unclip the bottom edge of the radio trim bezel and disconnect the hazard light, defroster, wiper and cigarette lighter wiring. Remove the radio trim bezel. Remove (4) screws securing the factory head unit and disconnect the wiring.

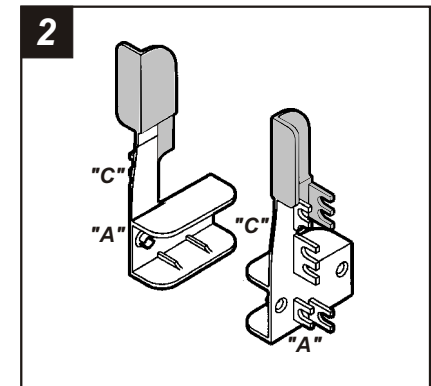
Cut **Bracket Set #2** along the scored lines removing the SHADED portions of the Brackets. Cut and remove all mounting tabs EXCEPT tabs "A" and "C". (The tabs can be identified by the stamped letter by each tab). Skip to the *Installation Instructions for ALL VEHICLES on Page #9*.

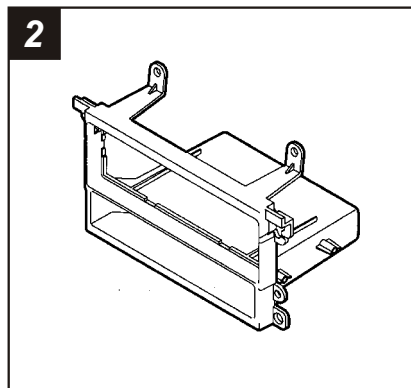
Cut and remove all mounting tabs on the **Radio Housing**. Skip to the *Installation Instructions for ALL VEHICLES on Page #9*.

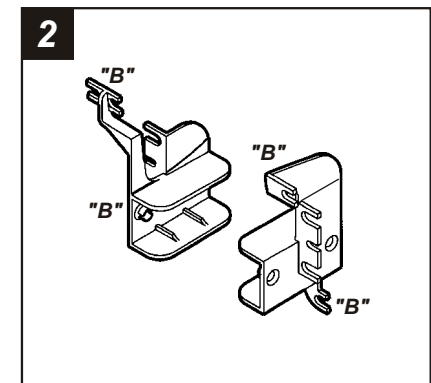
Cut and remove all mounting tabs from **Bracket Set #1** EXCEPT tabs "B". (The tabs can be identified by the stamped letter by each tab). Skip to the *Installation Instructions for ALL VEHICLES on Page #9*.
